First Church in Albany through the Eyes of a Scaffolder

Credit to Carl James of Tri-City Scaffold, Inc. and Dolores Diaz for Layher Inc.

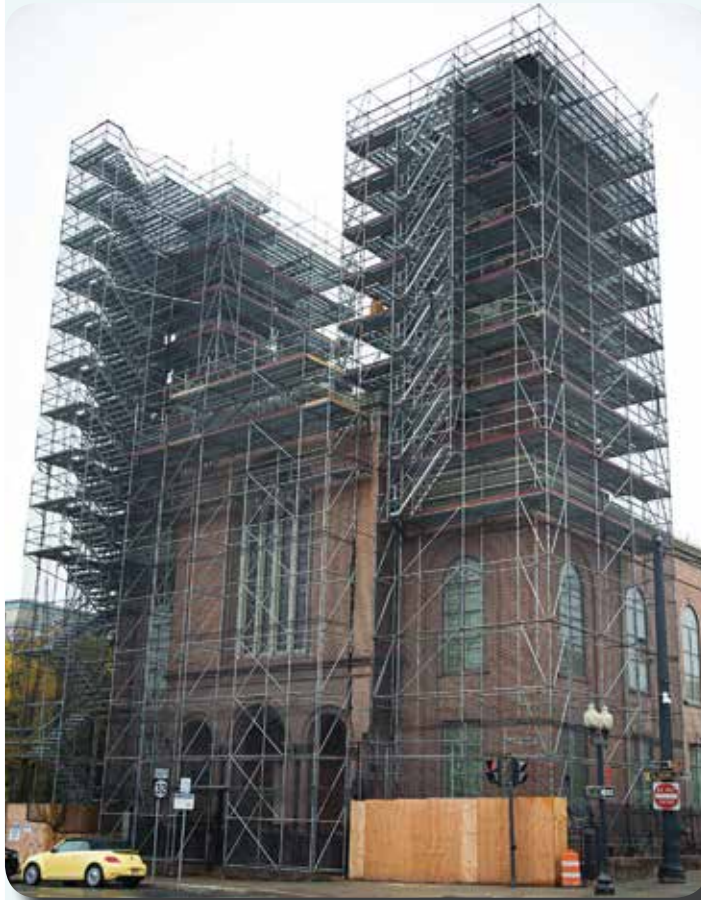
Front view of First Church renovation in Albany, NY. Tri-City installed 11 working levels of Layher Allround Scaffolding to provide access to multiple roof elevations, chimneys, and two spires in addition to overhead protection of sidewalks and doorways.

With both spires requiring major restoration, Tri-City installed a total of 11 working levels in addition to a stair tower to the south spire to access the levels easily. To achieve access to the north tower, a connecting bridge was installed between the towers above the main sanctuary roof. Aluminum stairs were installed on the north tower from the connecting bridge to each working level. This arrangement allowed 100% access to the towers and eliminated the need to move working levels as the project progressed, helping to achieve a more safe work environment.

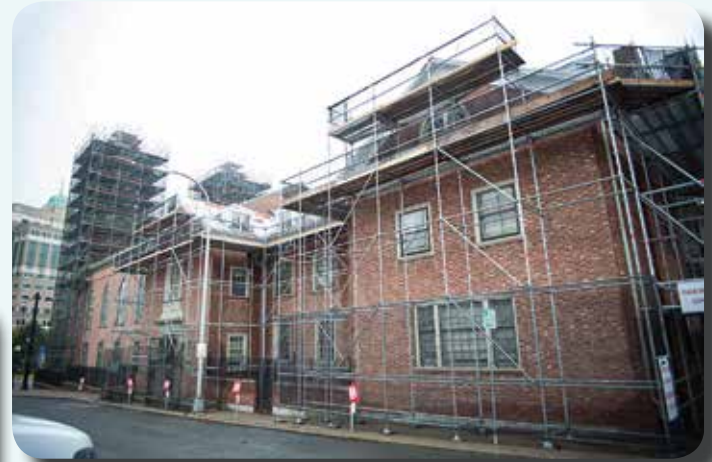
Side view of First Church renovation showing multiple roof elevations and working platforms. Renovation is estimated for completion in November 2015.

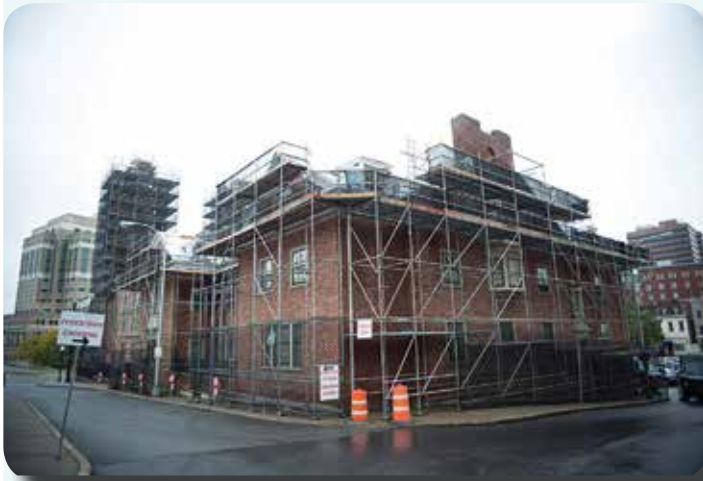
First Church renovation from behind church building. Layher Allround system scaffolding overcame ground elevation changes pictured through built-in versatility.

Utilizing Layher Allround® Scaffolding, Tri-City incorporated overhead protection of sidewalks and doorways with working scaffold to provide access for multiple roof elevations, chimneys, and two spires. The system scaffold overcame various ground elevation changes with the ease of built-in versatility. However, north and south towers presented a special challenge. When Tri-City began scaffolding for the south tower, they discovered that the over 200-year-old brick tower leaned approximately 4 inches south and 2 inches east. Fortunately, the scaffold legs barely touched the eave line, and progress was not inhibited.
